Semi-permanent solution for endodontically treated teeth

Dario Novak, dr.med.dent.

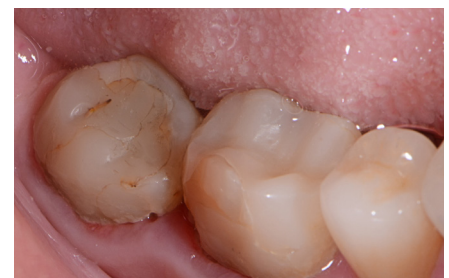
On clinical examination, we saw two teeth that had been endodontically treated and finished with composite fillings. The appearance of the fillings indicated that several filling procedures had been performed repeatedly. The gums were inflamed and of a livid color and bled when touched with the probe (Fig. 1).

Fig. 1: The initial state of teeth 46 and 47.

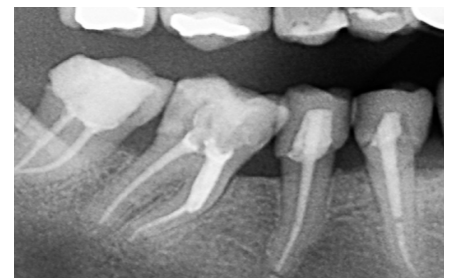
An RTG showed a minimal amount of the remaining hard dental tissue and a re-instrumentation of the mesial canal on tooth 46 (Fig. 2). With a combination of these two problems, this tooth posed a high risk for potential restoration and prosthetic work. The whole situation was explained to the patient.

Fig. 2: An X-ray of teeth 46 and 47.

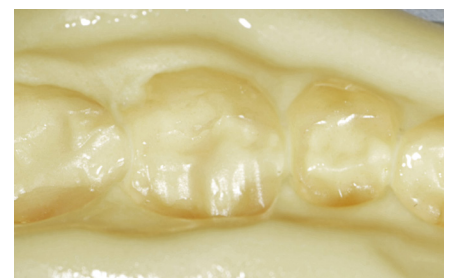
Fig. 3: An impression in condensation silicone.

The impression was taken in the condensation silicone Optosil so that the process could be repeated if necessary (Fig. 3).

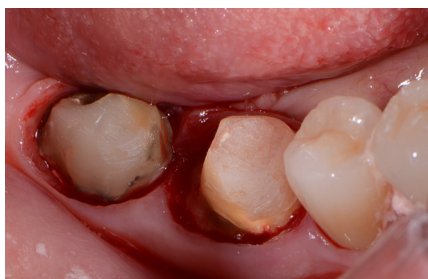
After taking the impression, we proceeded to tooth preparation, in which a large amount of dental structure was lost. The vast majority of fillings was decaying, and the severity of the problem regarding tooth 46 was noted (Fig. 4).

Fig. 4: Situation after tooth preparation.

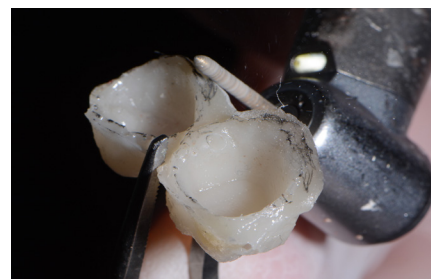
Fig. 5: Shaping and polishing of the temporaries.

After making the crowns in the Optosil mold, we used a pencil to indicate and better see the edges of the crowns to be drilled (Fig. 5). After processing, we set the crowns in place and filled the spaces with flowable composite to the edges of the preparation area (Fig. 6). After bite adjustment, we coated the crowns with LuxaGlaze to ensure the perfect polish and shine of the semi-permanent crown surfaces. The crowns were cemented with non-eugenol cement, TempoCem NE in this case, in order to check the function and gum reaction (Fig. 7).

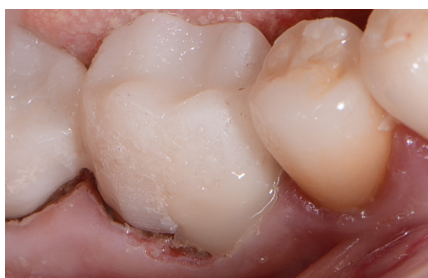
Fig. 6: Using the flowable to fill the gaps.

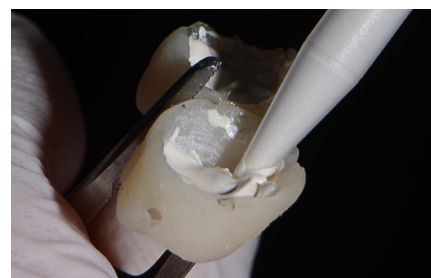
Fig. 7: Filling the crowns with TempoCem NE.

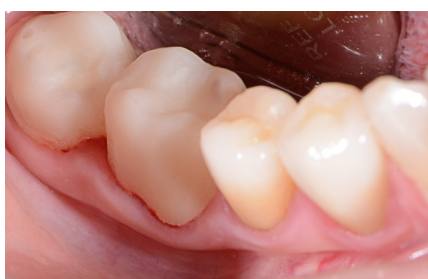
After a month of the trial period, the patient reported considerable improvement related to the gums, oral hygiene, and chewing function (Fig. 8). After removing the crowns, the gums showed a significant improvement in terms of healing (Fig. 9). Thus, we decided to remove the temporary cement and cement the crowns permanently (Fig. 10). The final picture shows their appearance after 18 months of function (Fig. 11).

Fig. 8: After one month of trial period.

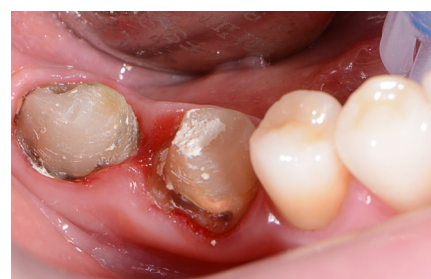
Fig. 9: After removing the LuxaCrown crowns.

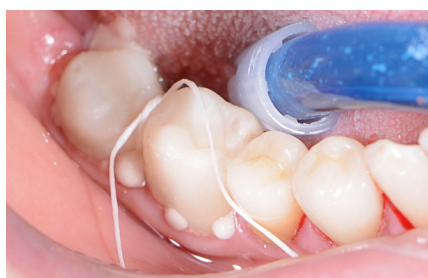
Fig. 10: Cementing with Fuji Plus.

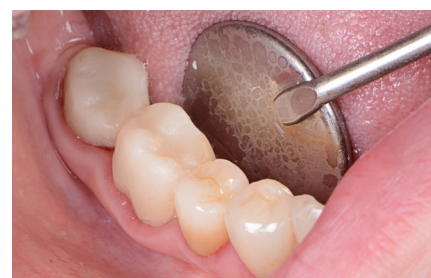
Fig. 11: Final result 18 months after cementing.
