# QUICK CASE: Dr. Gary Radz

↖ **Ecosite Bulk Fill** ↖ **LuxaCore® Z Dual**  
↗ **Honigum Pro**

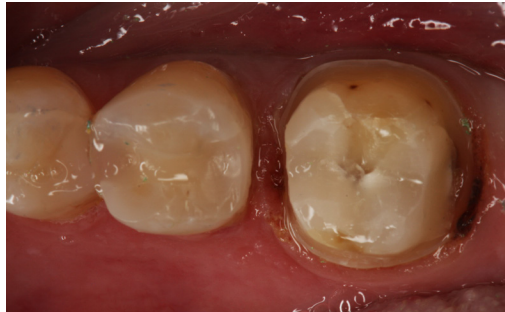
- ↖ #29 - Large failing MOD amalgam, radiographic recurrent mesial decay
- ↖ #30 - Large amalgam present as well as temporary restoration on the mesial and structurally compromised to the point where a build up and crown are necessary

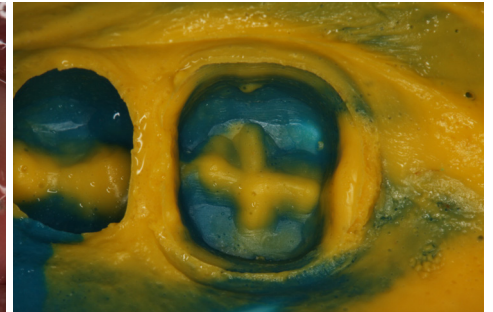
- ↖ #29 - Restored with an MOD restoration using **Ecosite Bulk Fill** (universal)
- ↖ #30 - Old restorations were removed, recurrent decay was excavated, the tooth was restored with a build up (**LuxaCore Z Dual - A2**) and prepared for a zirconia crown
