CASE REPORT

Restoration Using Ecosite Elements for #8 MIFL Fractured Enamel

Case Presented By: Dr. Neville Hatfield

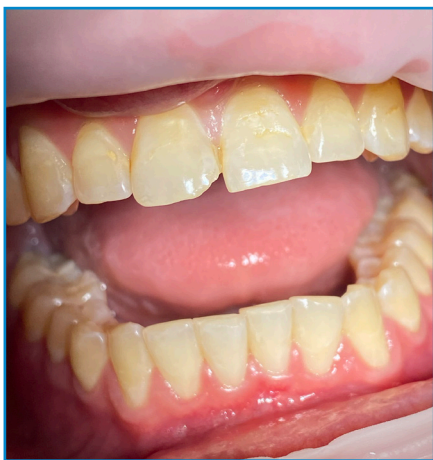
Fig. 1 Initial presentation, facial view

A 22-year-old male presented with fractured enamel on tooth #8 (MIFL) and recurrent decay underneath their previous restoration (figs. 1, 2).

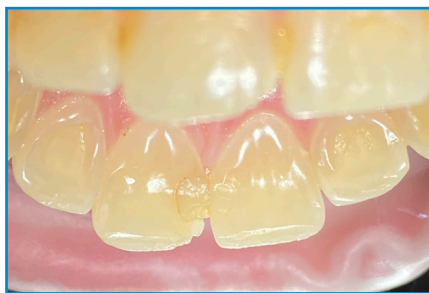
Fig. 2 Initial presentation, lingual view

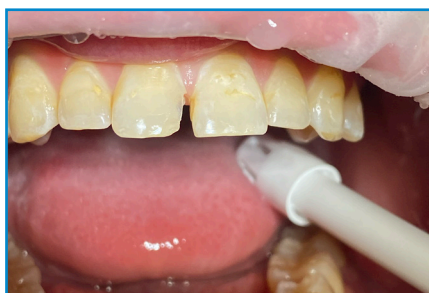
Fig. 2.5 Facial view of the tooth after beveling enamel

I first removed the old restoration and beveled the enamel as needed (fig. 2.5). The patient's base shade of #8 is Vita Shade A2.

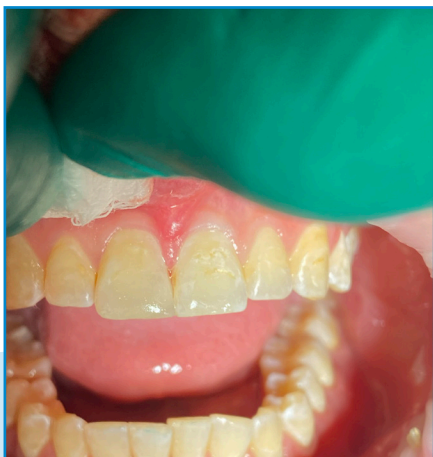
Fig. 3 Final presentation, facial view

To create the restoration, I used Ecosite Elements Pure-B1 Shade (DMG) in conjunction with Ecosite Elements-Enamel Dark Shade (DMG) to achieve an accurate match for both shade and opacity, taking into consideration that the patient does not have very translucent enamel (fig. 3, 4).

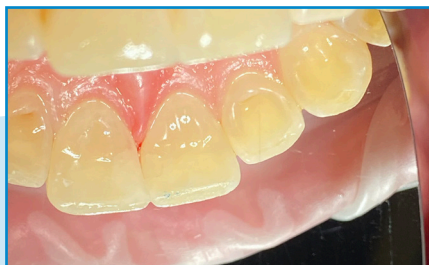
Fig. 4 Final presentation, lingual view
